GI WACAF: Oil Spill Response Webinar

South Africa NOSCP & Case Study

16 September 2020
Capt. Ravi Naicker

Case Study

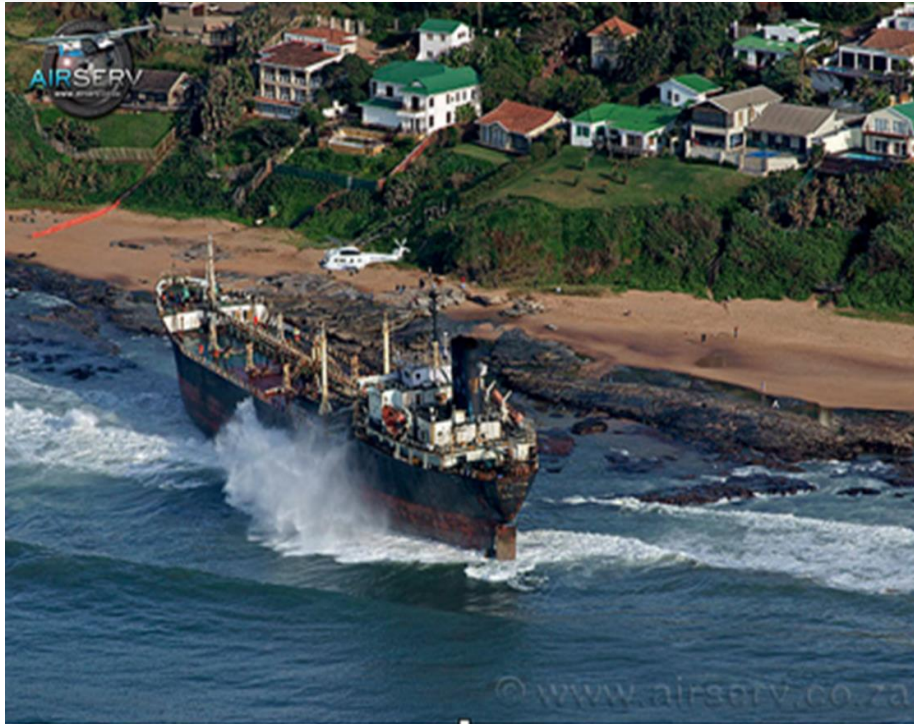
The vessel was enroute to Alang, India **to be scrapped**, experienced engine failure ran aground at Salt Rock north of Durban, 2011.

Gross Tonnage: 8 124
Length Overall: 164m
Breadth Extreme: 26m
Year Built: 1974

1. ETV, SA Amandla, on contract to DoT dispatched to tow the vessel.
2. Vessel had **no insurance** or **P&I** cover in place.
3. SAMSA instructions issued to the Master
4. SAMSA approached the High Court and an order for detention, **seizure** and **sale** was granted on 22nd July 2011.
5. Vessel could **not** be brought into port as TNPA refused to allow the vessel in Port.
6. On the evening of 25th July the vessel started dragging her anchor and drifting to shore
7. Phoenix kept drifting and in the morning of 26th July grounded at Sheffield Beach.
8. 15 crew members were airlifted by the South African Air Force, SAPS and TNPA.
9. On board was approx. **450m³** of Fuel Oil

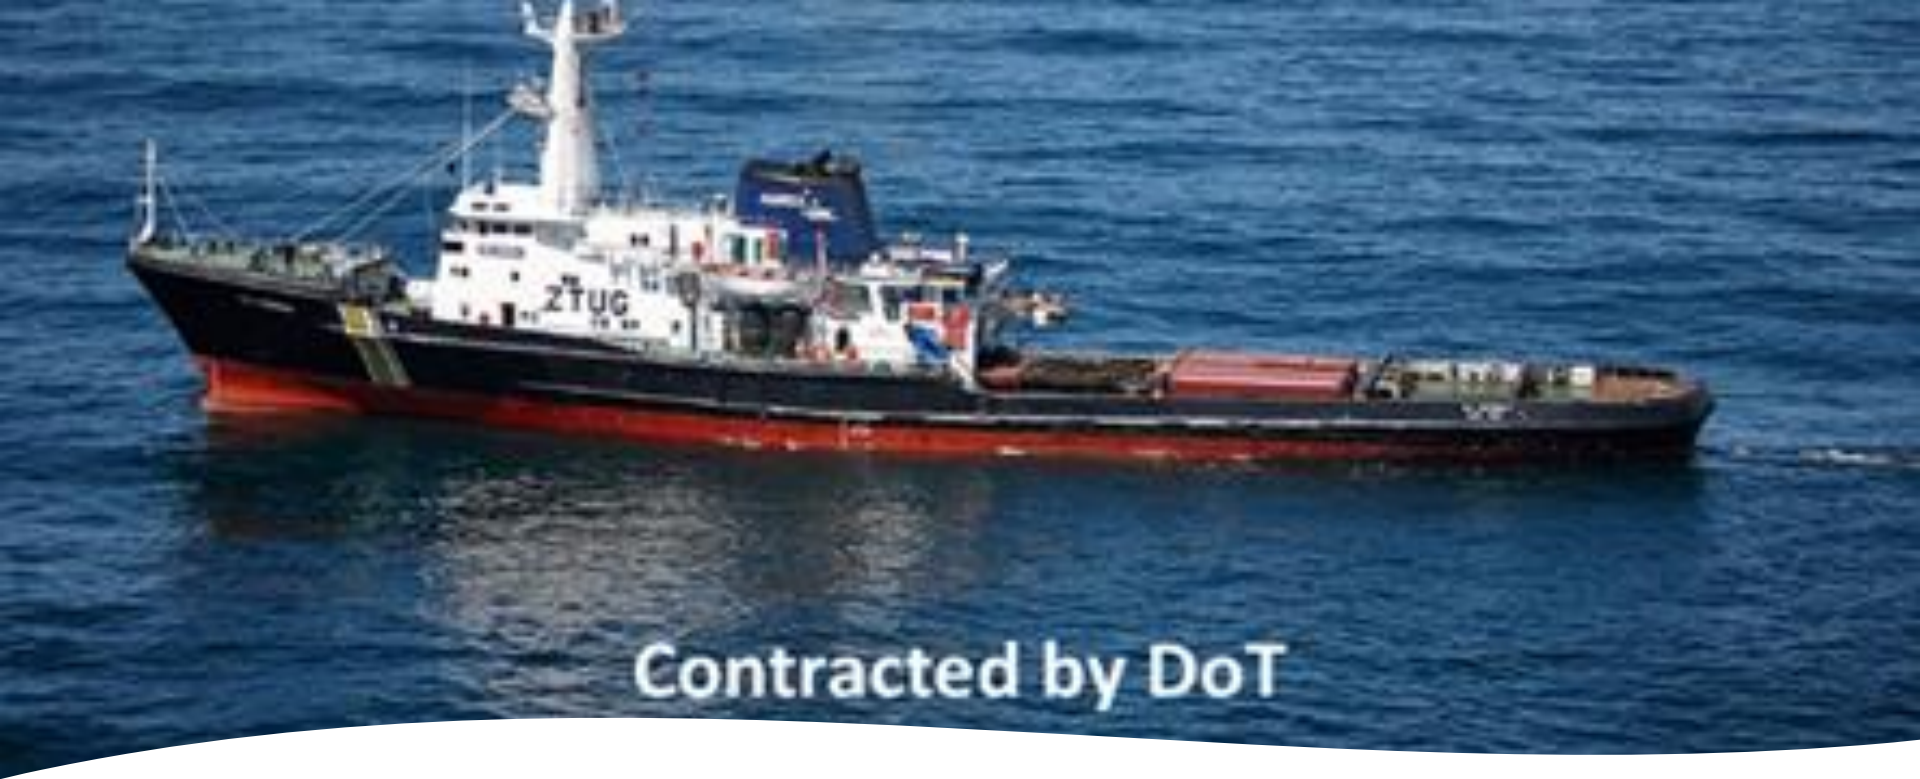
MT Phoenix

The SA Amandla, attempted to reconnect the tow, but due to inclement weather the tow line could not be connected.

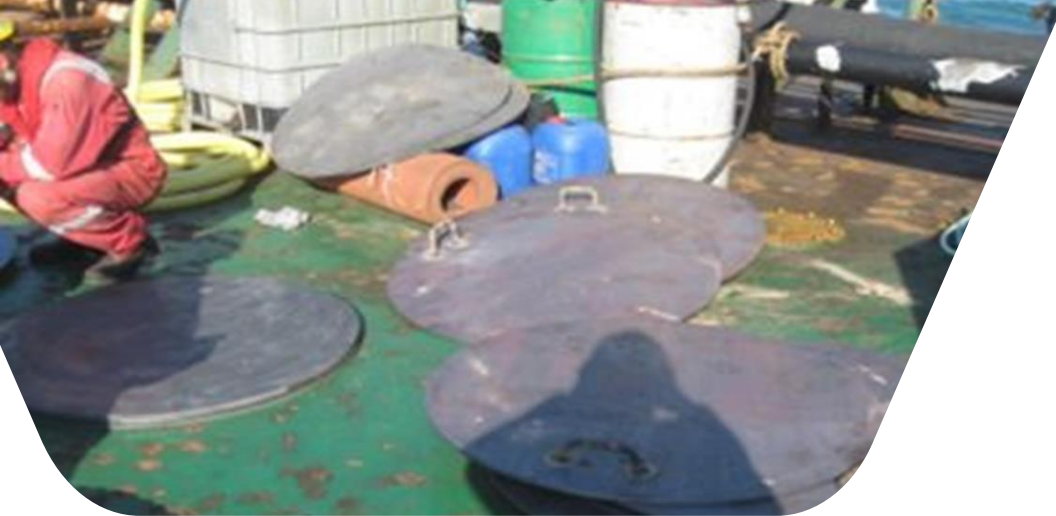
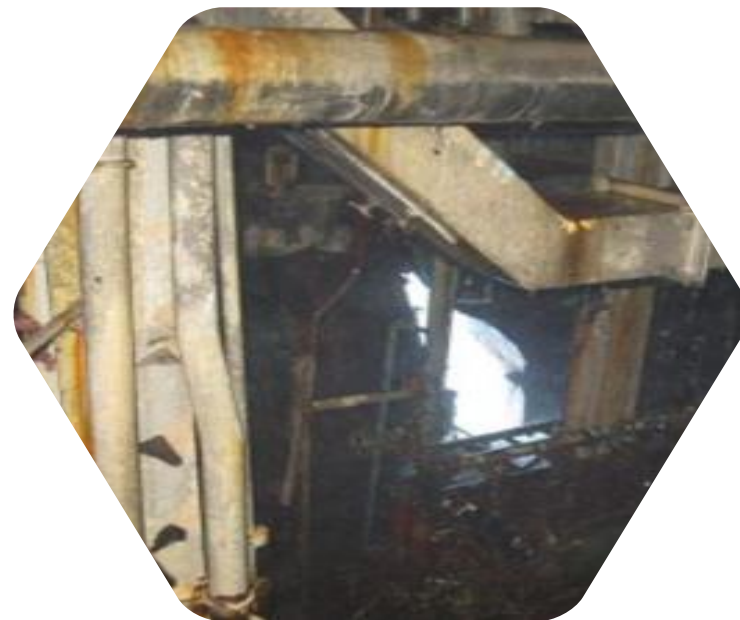
MT Phoenix

1. Hull integrity obtained by patching and sealing all compartments
2. Engine room damage could not be patched due to size and elements of weather

1. Salvage operations commenced on 27th July 2011
2. SMIT Salvage were appointed salvors, Subtech group were also involved in the salvage
3. Equipment brought in and **flown** by helicopter onto the vessel
4. **Priority** to discharge the Fuel Oil
5. Beach access

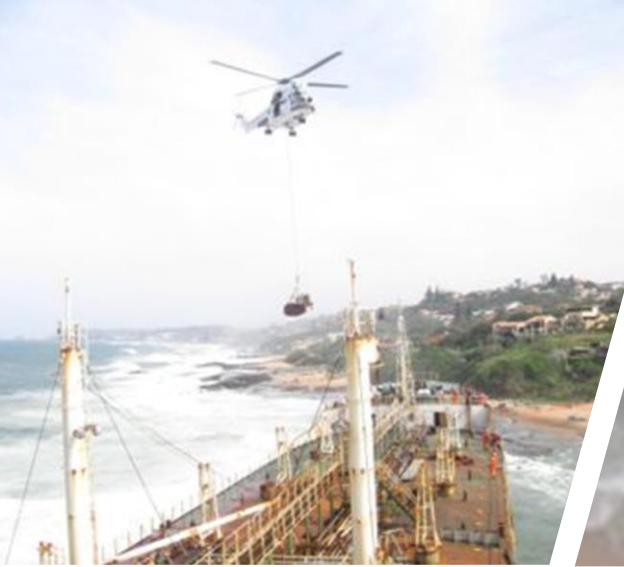
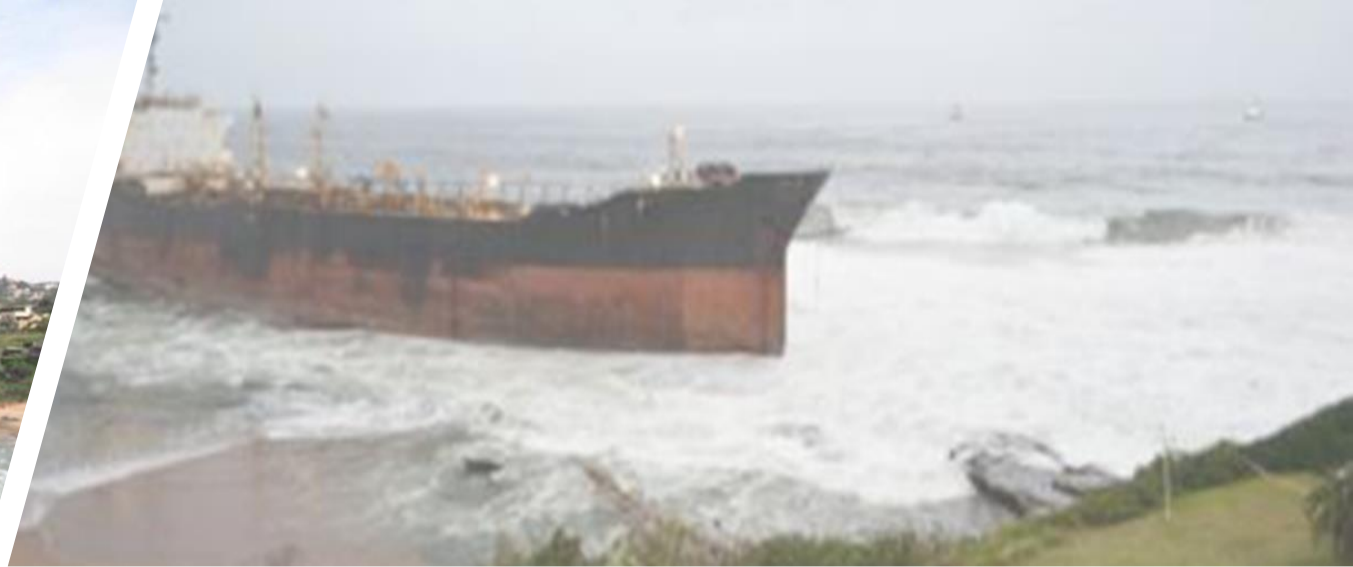
Walkway fabricated

- Access to vessel
- Save helicopter costs
