Case study: Shoreline clean-up

Collision off Cap Corse, France, October 2018

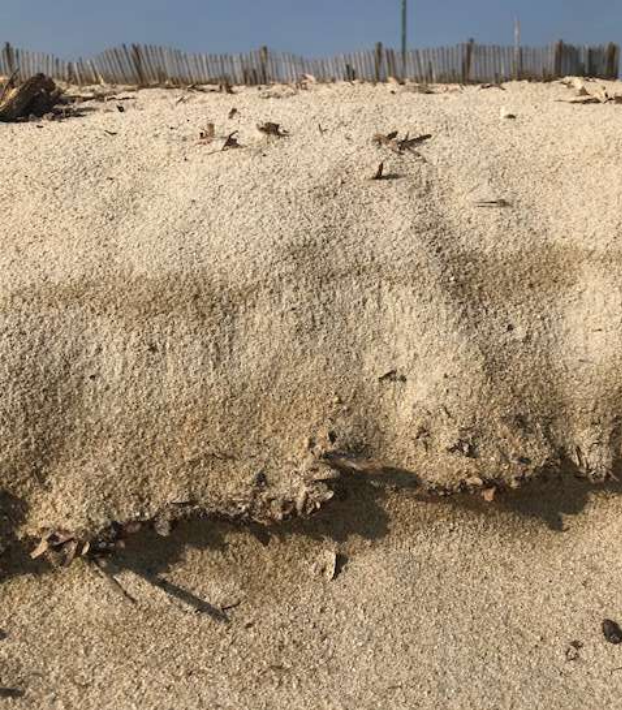
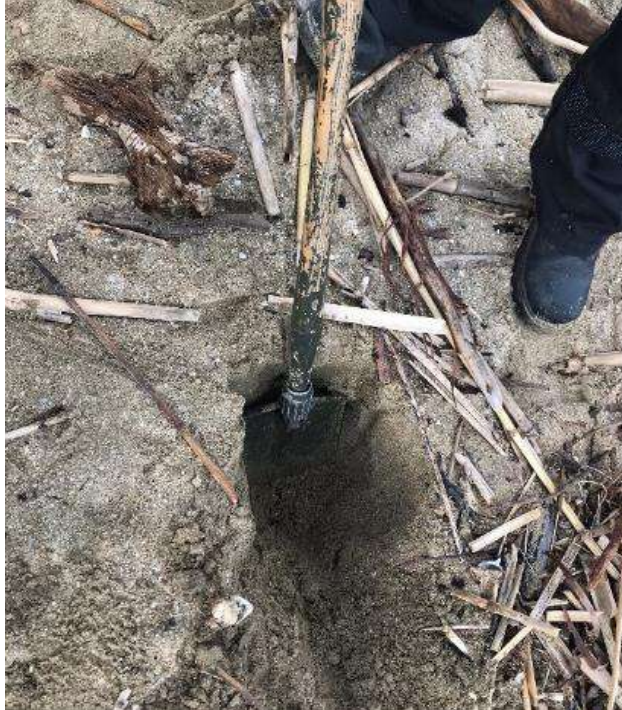
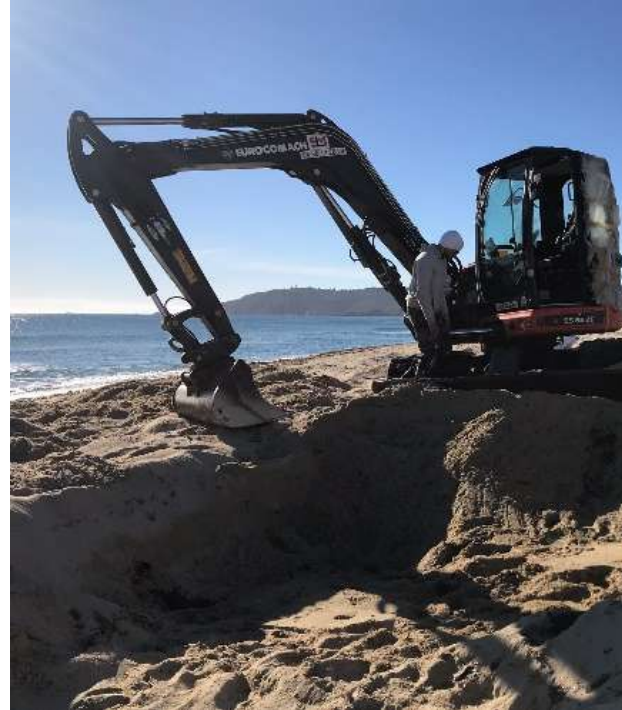
Tarballs/ patties on the surface

Manual pick-up with segregation to limit the amount of waste generated

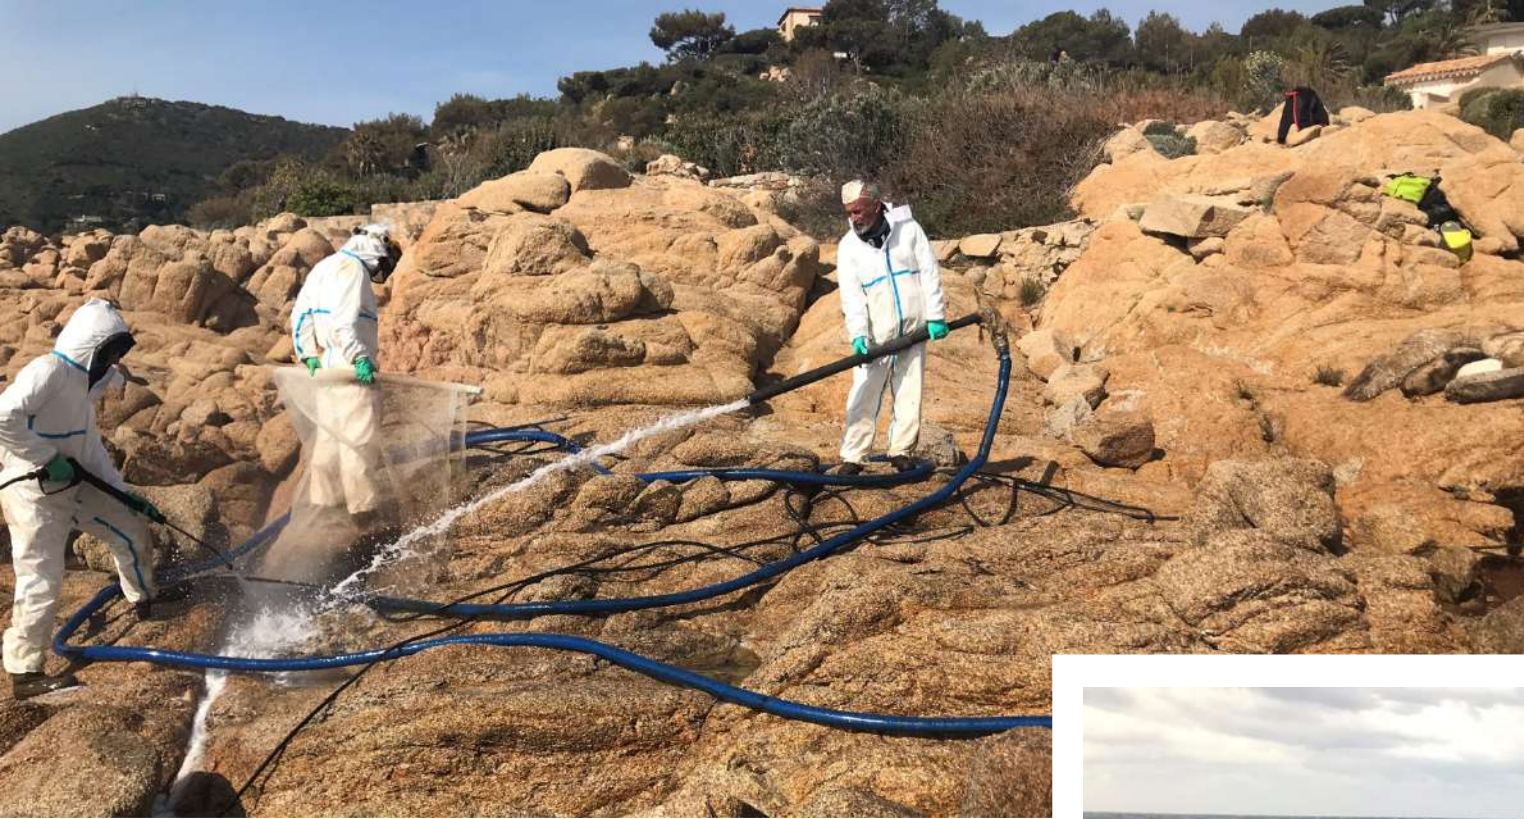
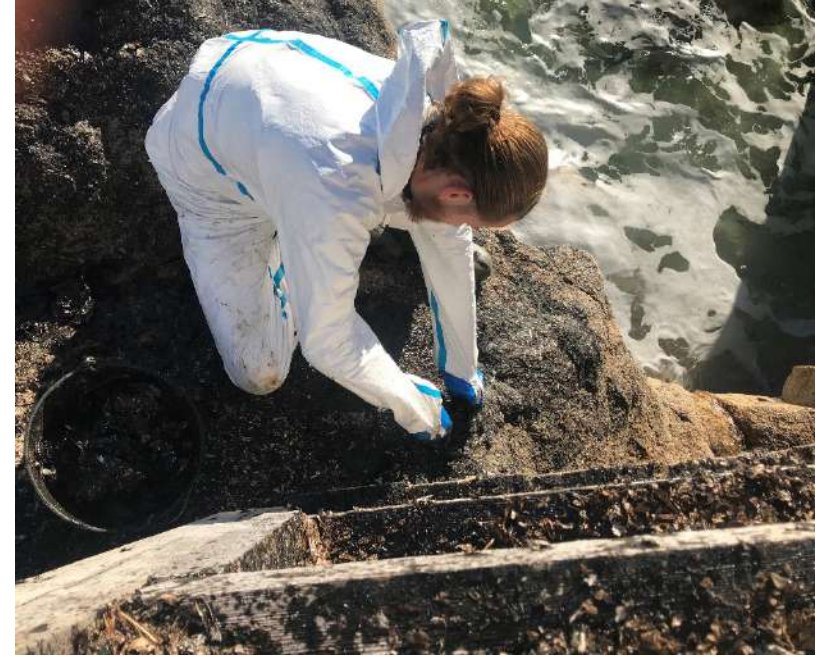
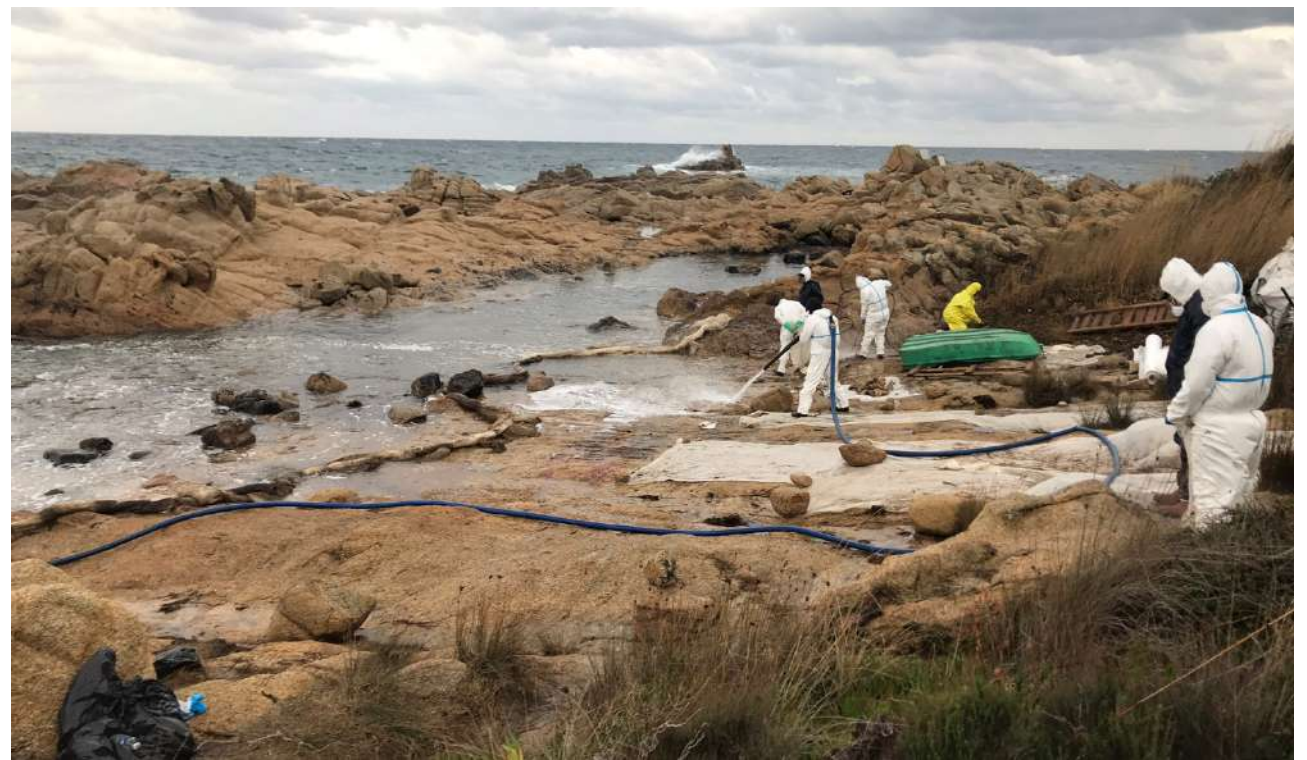
- Buried oil
- Dynamic shore (sandwich)

- Survey and excavation
- Flushing et manual recovery

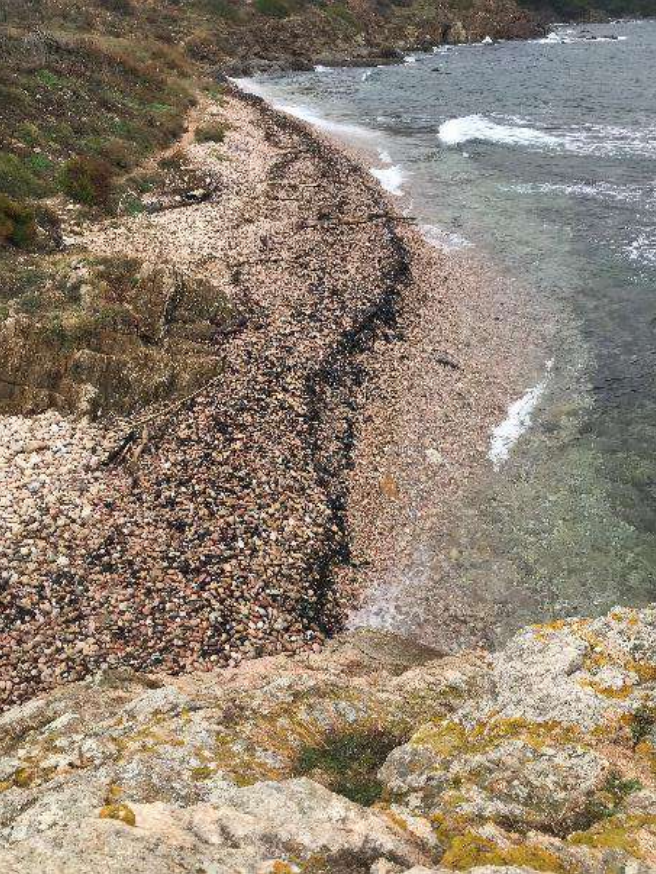
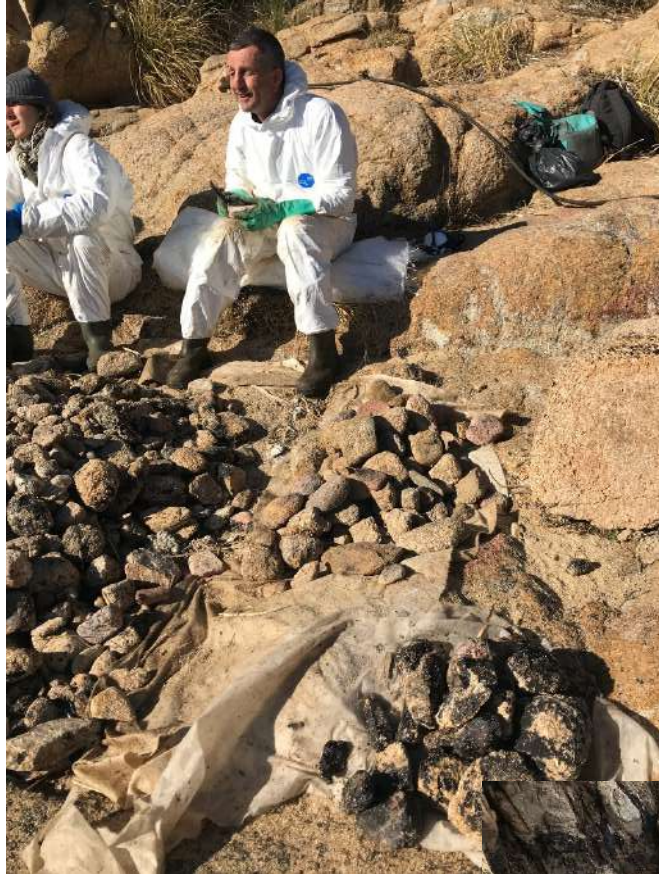
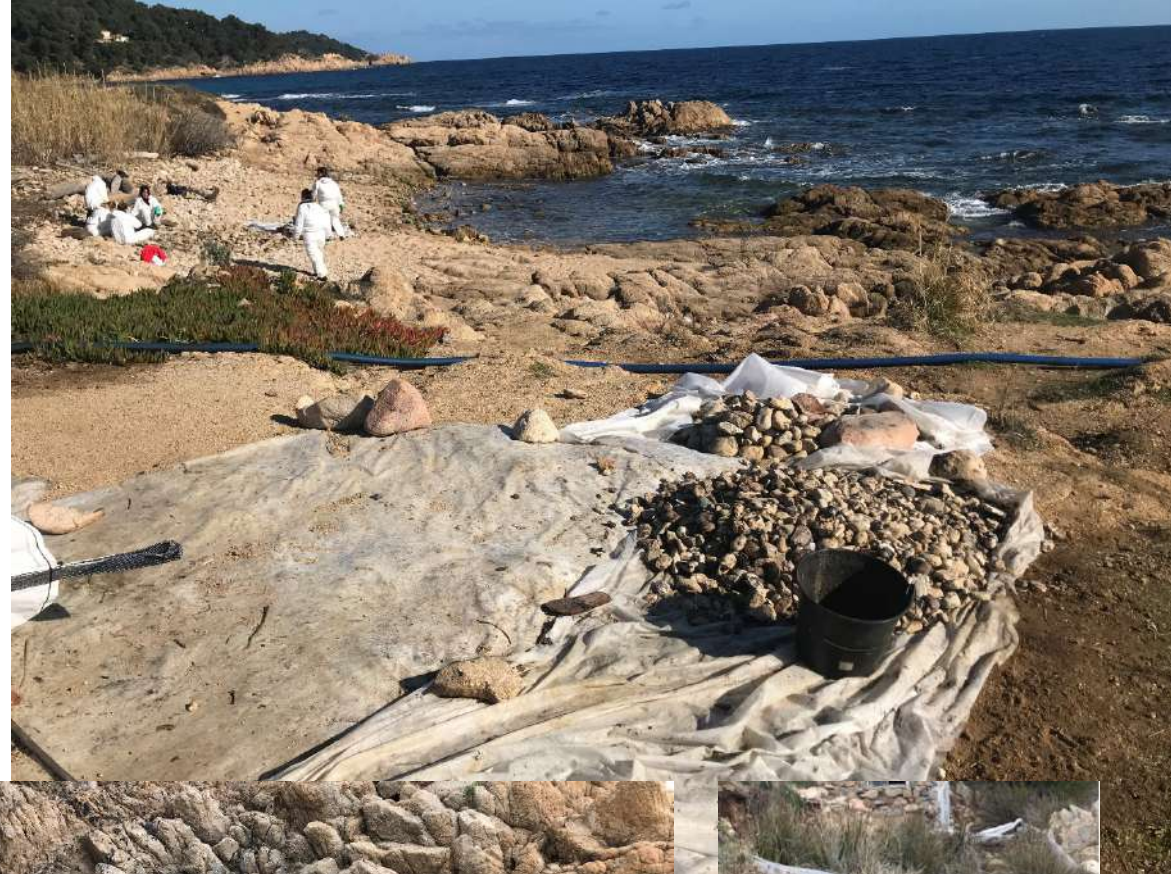
Rocky shoreline

- Removal of thick patches by scraping
- Flushing
- HP
- Protection of the cleaned areas against oil splashes with geotextile

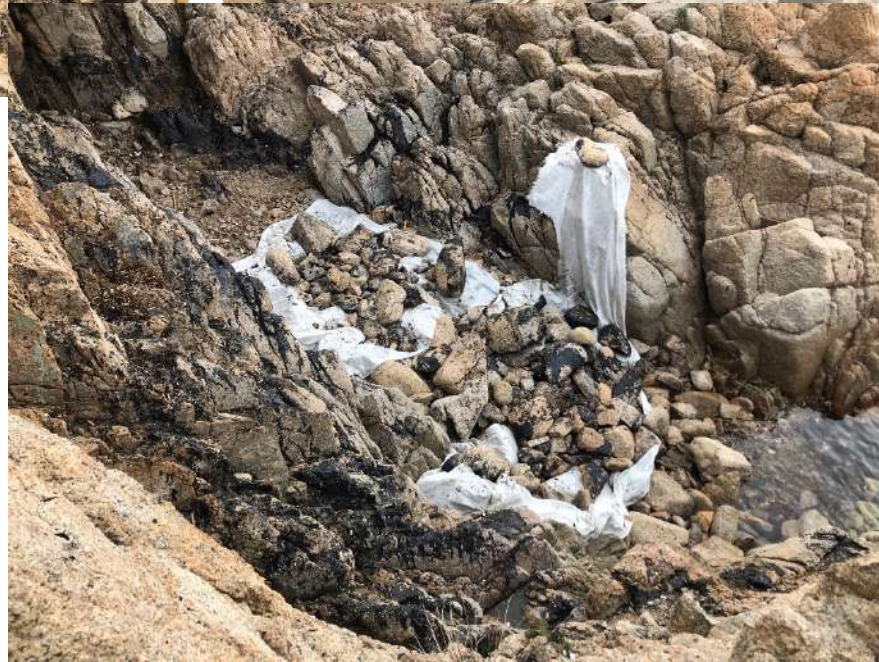
Pebbles/Cobbles

- Manual collection
- Scraping/ Brushing
- Flushing and HP
- Concrete mixer
